# SANITARY SEWER COLLECTION SYSTEM INSPECTION

Inspector name: Eddy Bouzeid Inspector BG#: 34175  
Inspector name: \_\_\_\_\_ Inspector BG#: \_\_\_\_\_  
Inspector name: \_\_\_\_\_ Inspector BG#: \_\_\_\_\_  
Permit #: TN0066800 Inspection Date: 5-9-2017  
System Name: Somerville Lagoon  
City: Bartlett Address: 6400 Stage Road, Bartlett, TN 38134  
System Representative: Matt Crenshaw Position: Division Manager  
Phone number 901-385-5586 E-mail address mcrenshaw@cityofbartlett.org  
System Representative: Don Ervin Position: Field Supervisor  
Phone number 901-385-5586 E-mail address dervin@cityofbartlett.org  
Certified Operator: Matt Crenshaw Grade: 2  
Phone number 901-385-5586 E-mail address mcrenshaw@cityofbartlett.org

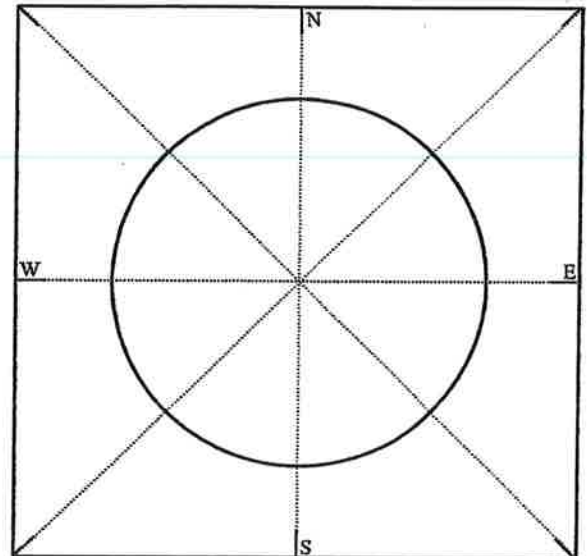
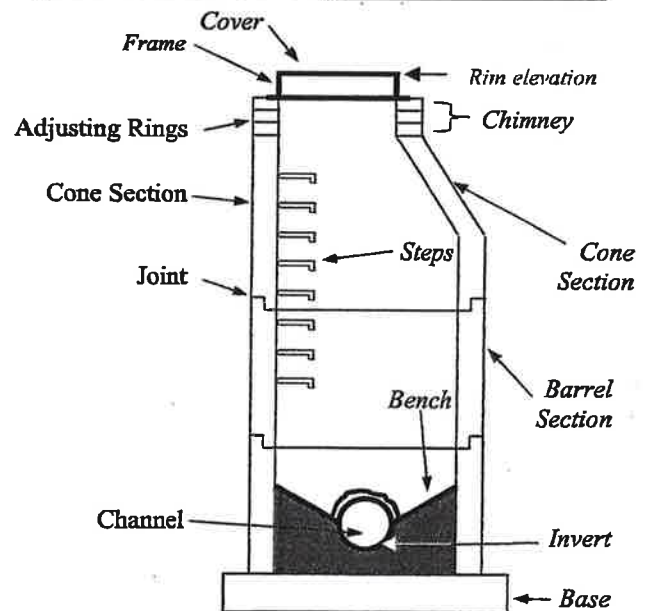
Location: 6487 Cohay

Is there any evidence of a recent overflow? NO

Is there staining indicating I&I? NO

Is there Grease or solids buildup? NO

Odor? NO Rooting? NO Flow observation (slow/backed up)? normal

Discuss the structural integrity: Good

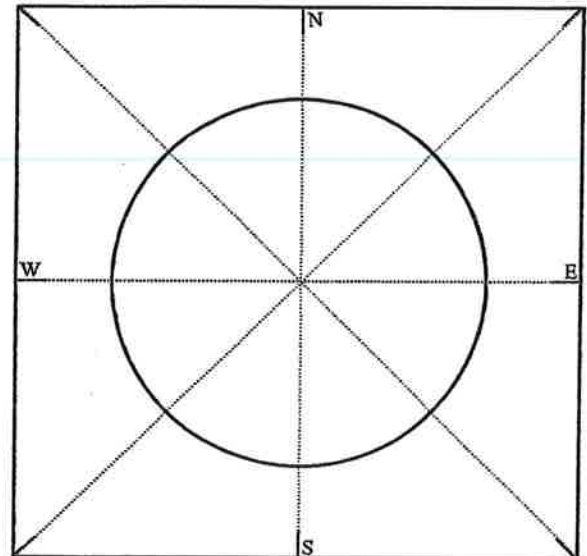
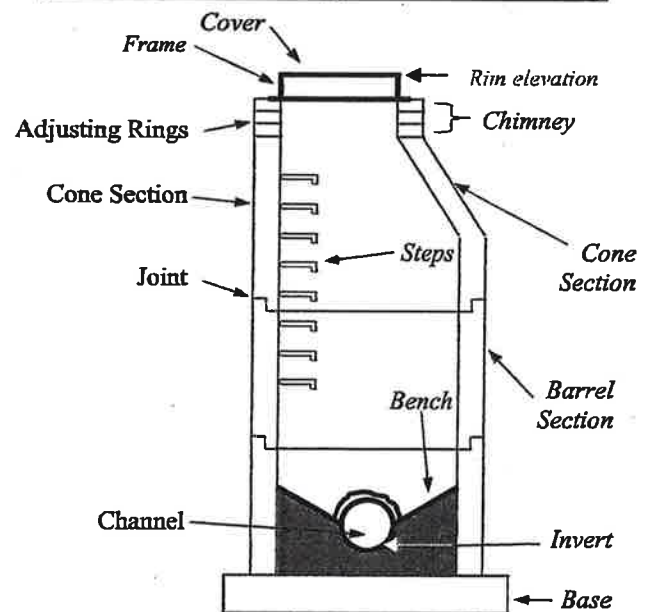
Location: 3520 Carthstone Cove

Is there any evidence of a recent overflow? NO

Is there staining indicating I&I? NO Is there Grease or solids buildup? NO

Odor? NO Rooting? NO Flow observation (slow/backed up)? normal

Discuss the structural integrity: good

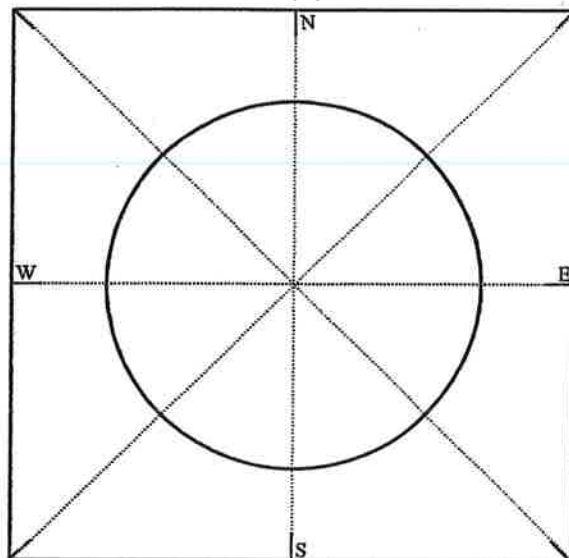
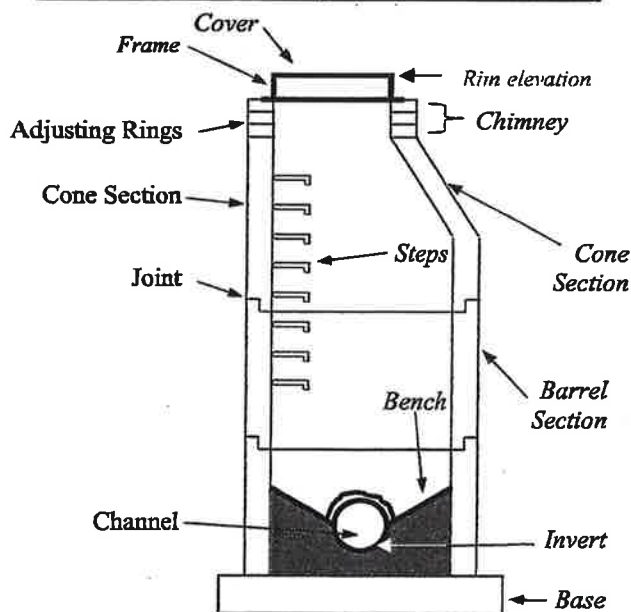
Location: 3588 Charlene

Is there any evidence of a recent overflow? NO

Is there staining indicating I&I? NO

Is there Grease or solids buildup? NO

Odor? NO Rooting? NO Flow observation (slow/backed up)? normal

Discuss the structural integrity: good
